Class 2 Flood Hazard Assessment

Lots 75, 76, 77, DL 530 & Rem DL 530 & Lot 4, KDYD, Plan KAP79399 on Monck Road, near Merritt, BC

18100692-001-R-Rev1

5 July 2018

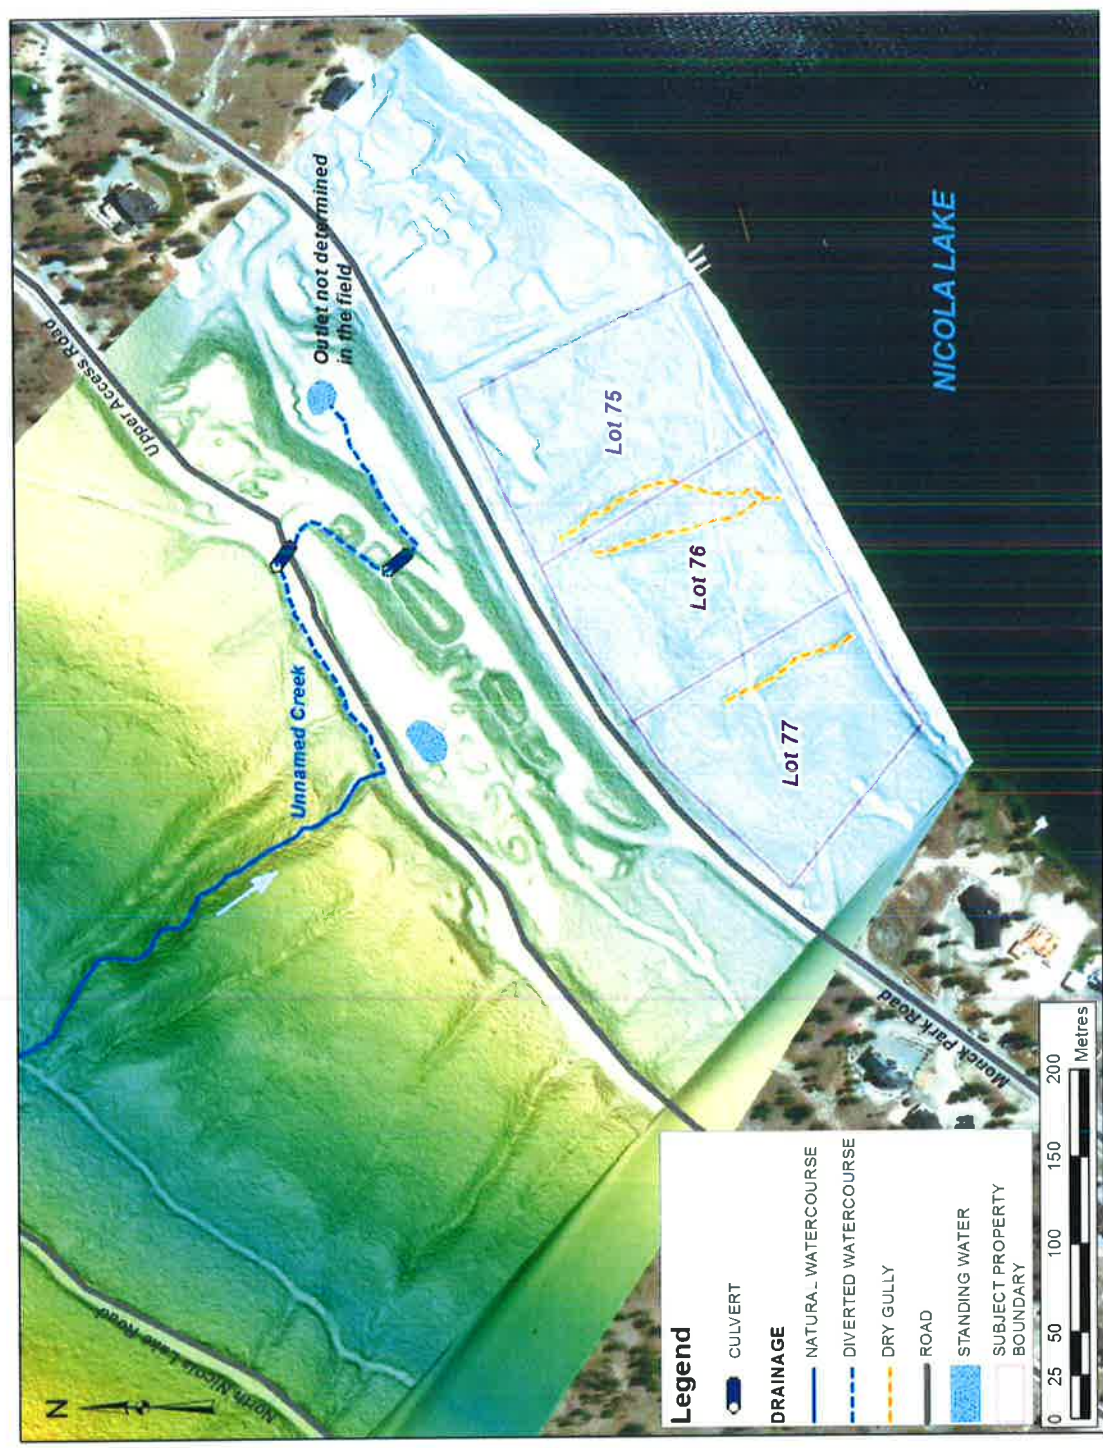
Figure 2: Drainage features above and at the subject property (hillside elevation shading is from the LIDAR data)

Under the design flow conditions, the roadside ditch will not have sufficient capacity to safely convey the flow. The Upper Access Road will be overtopped which will lead to overland flow in the borrow pit area. It is anticipated that after flow passes the borrow pit area, Monck Park Road will be overtopped and there will be overland flow on the subject property and concentrated flow in the existing gullies on the subject property. This creates a potential overland flood hazard for the entire subject property.

Hydraulic analysis was completed to support the evaluation of conceptual flood mitigation options at the subject property. This included review of existing conditions, conceptual sizing of an open channel or pipe system that would be required to safely convey the peak flow rate from the gully of Unnamed Creek to Nicola Lake, and storage of the flood hydrograph volume. The existing conditions include the diversion of runoff from Unnamed Creek around the existing borrow pit and away from the subject property. However, this system is ill-defined and generally consists of roadside ditches which would not have the capacity for the design flood (Figure 2).

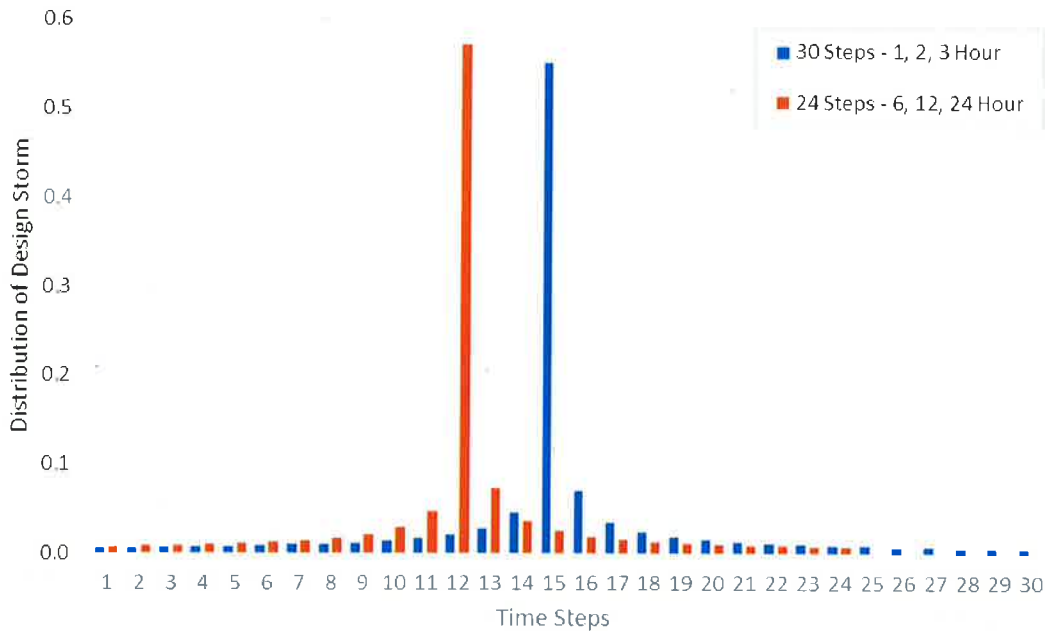
Figure 3: Design Storm Distributions (No Units)

Design storms for these rainfall depths were developed using the alternating block method (Chow et al. 1988). For storm durations of 1, 2, or 3 hours a time step using 30 increments was applied. For storm durations of 6, 12, or 24 hours a time step using 24 increments was applied. These increments were selected such that the time steps were round numbers in the hydrological model (i.e., 2, 4, 6, 15, 30, and 60 minutes, respectively). The storm distribution for each synthetic design storm is shown in Figure 3.
